Site Survey Report

Acme Company Corp.

Subject: Certified Free-Space Optics Site Survey Report and Installation Considerations

Date: September 22, 2008

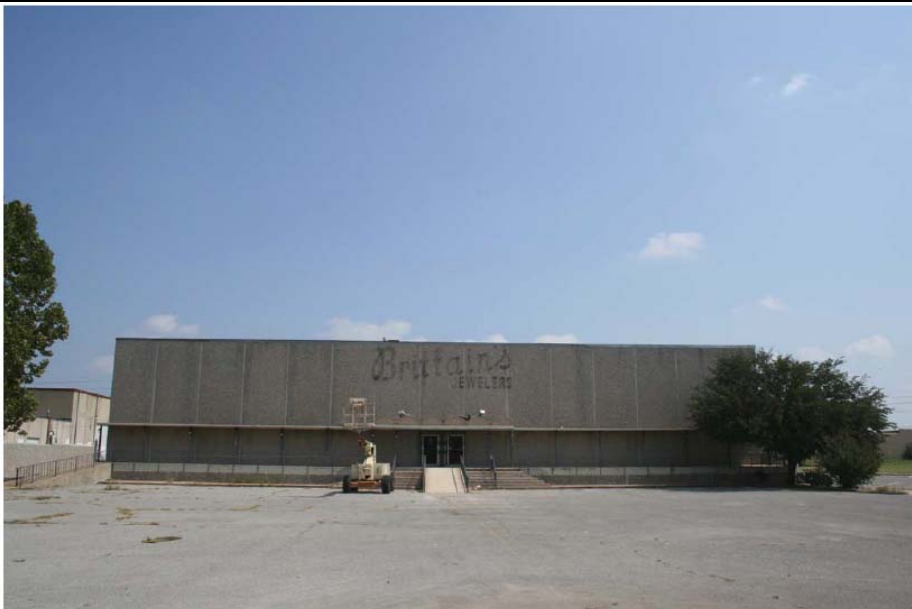
<p>Site A (Host Site)</p> <p>Acme Company Corp. 500 Montgomery Sq. Sometown, OK USA</p>

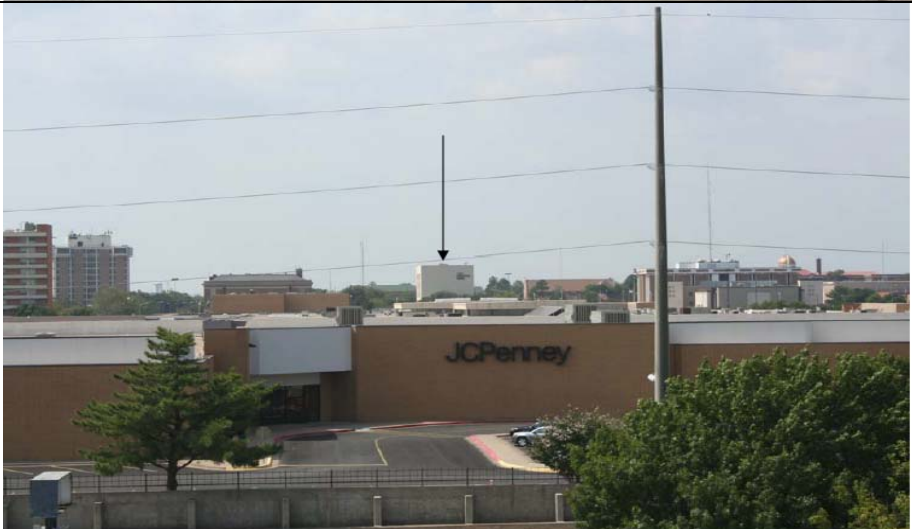
<p>Site A Rooftop line-of-sight view looking at Site B</p>

<p>Site A rooftop line-of-sight view to Site B. Tree trimming / maintenance is under our control. Power lines are in background.</p>

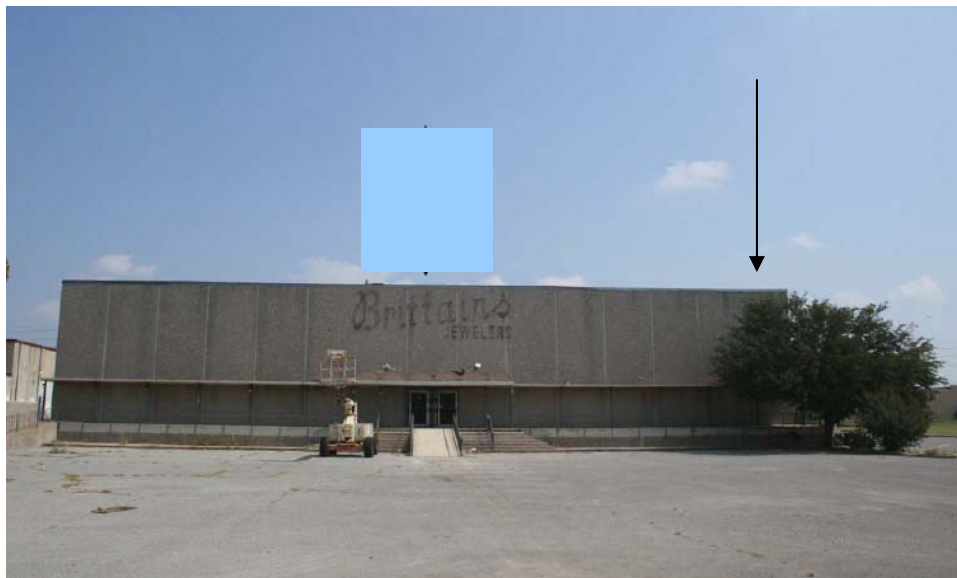
Site A
Rooftop view of mount location

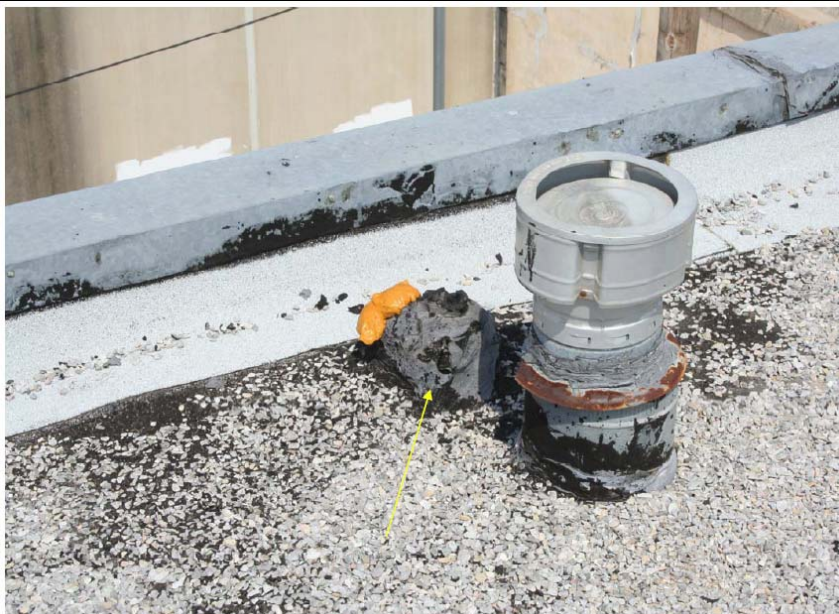
Site A
Rooftop penetration location

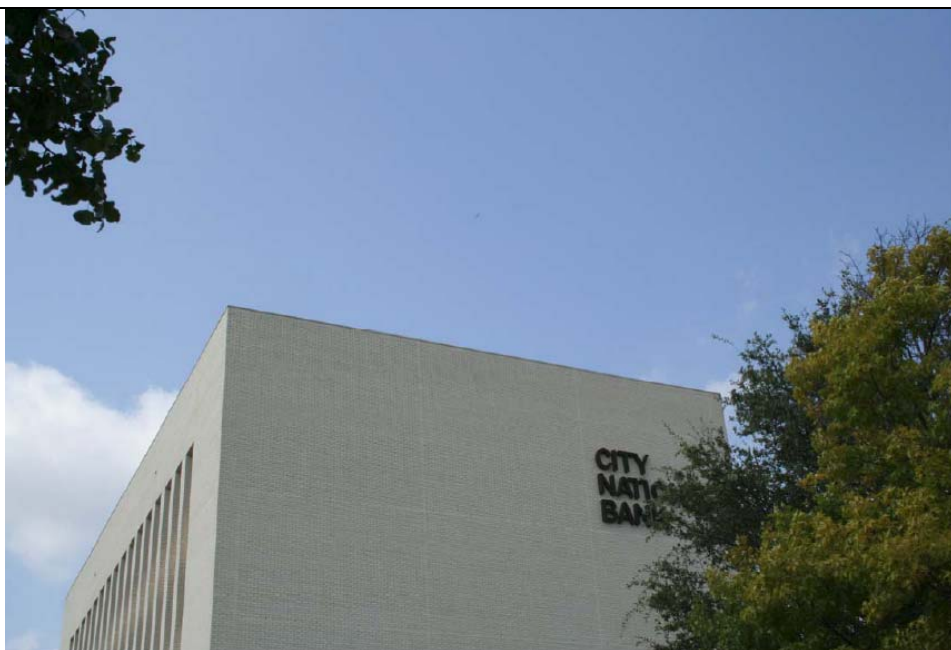
Site B
Street view

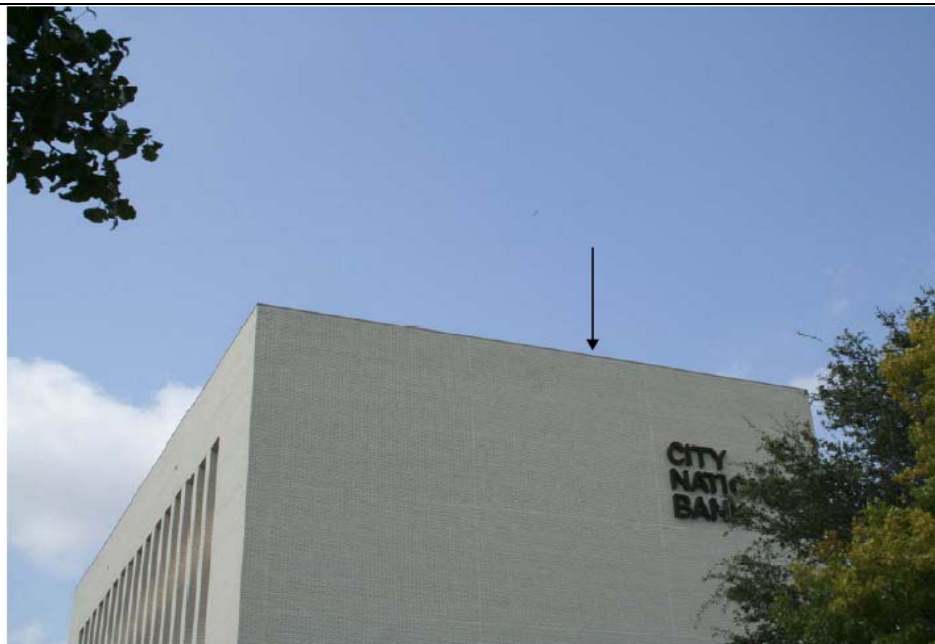
Site B (Remote site)
Link head position viewed from street level

Site B transceiver position viewed from the street. Trees are trimmed below sight line.

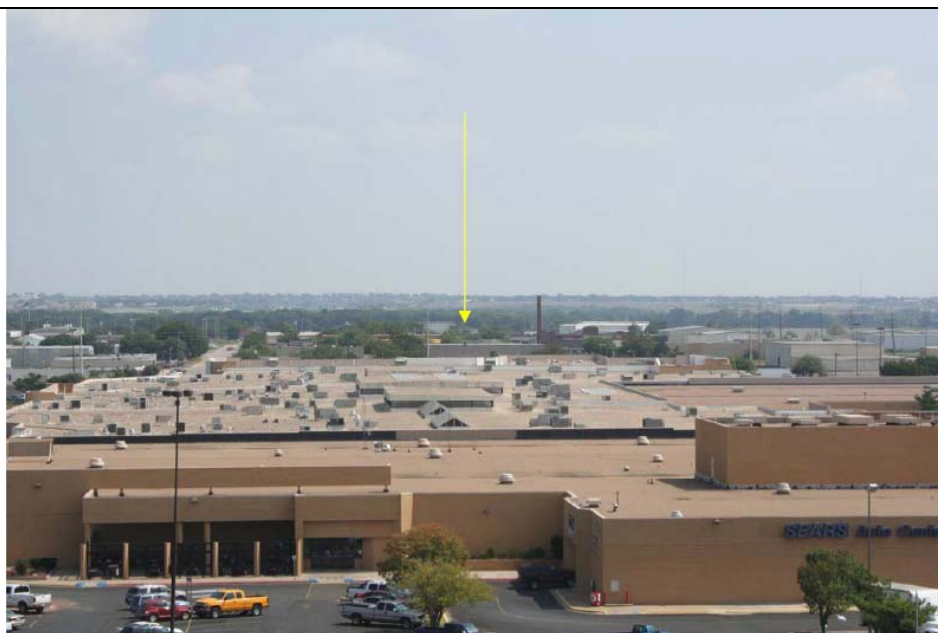
Site B
Rooftop line-of-sight view looking at
Site A

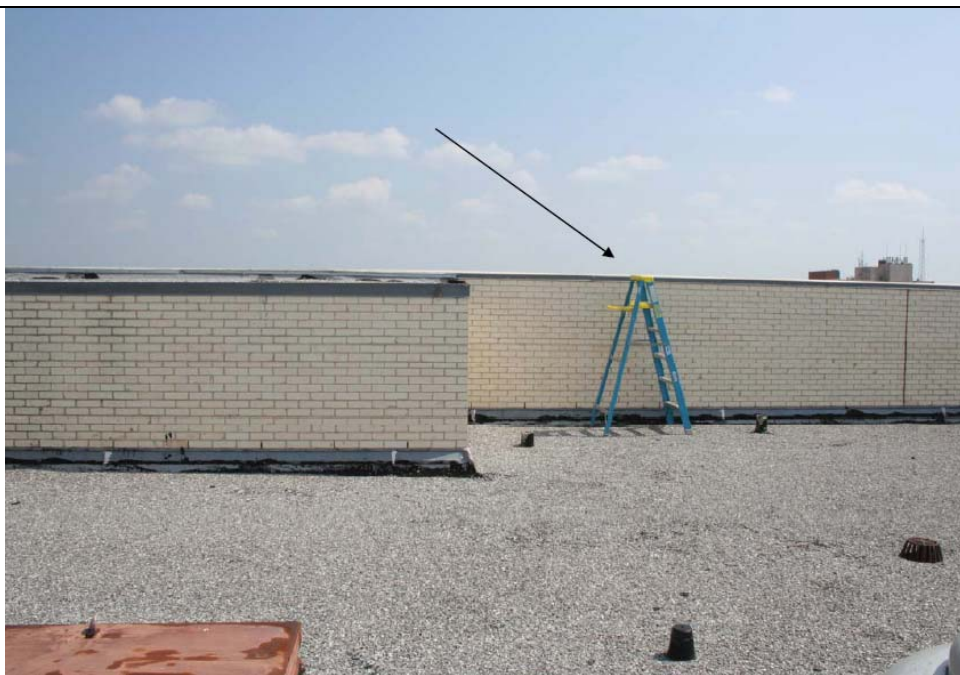
Site B
Rooftop view of mount location

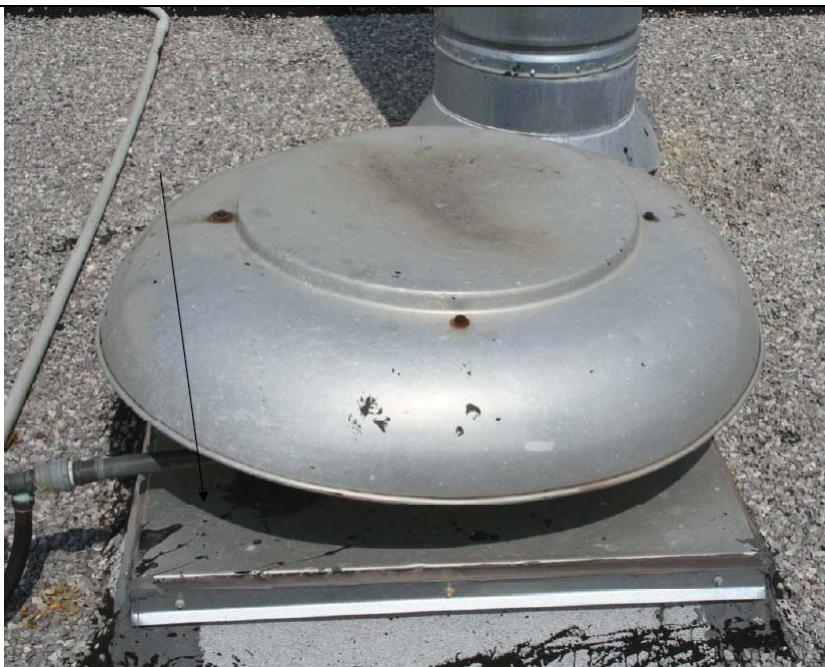
Site B
Rooftop penetration location
